A FULL RESERVE STUDY FOR

**Coconut Shores Community Association, Inc.
Bonita Springs, Florida**

File # 22920-05867

FOR PERIOD: January 1, 2012 – December 31, 2012

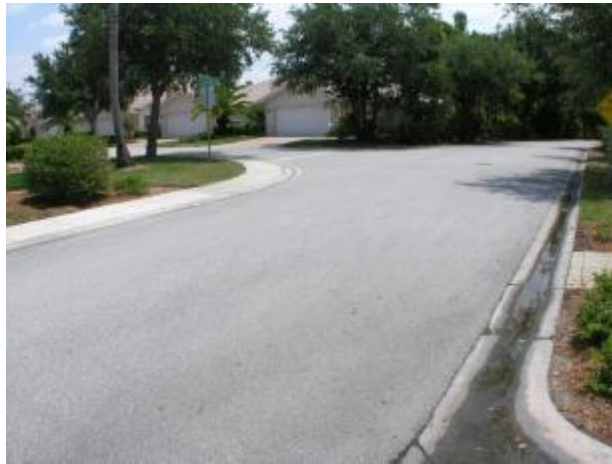
We have observed life cycles of less than 15 years, to 25+ years, for installation of asphalt overlays/repaving. The useful life typically depends on the quality of installation/materials, level of ongoing maintenance, and association cosmetic tastes. Since they may not be completed consecutively, we have provided separate line items for the clubhouse parking lot (+/- 1,335 sq yds) and the roadways (+/- 13,036 sq yds). The current cost estimates include as needed milling of the asphalt paving at its junction with adjacent concrete paving, typical minor repairs to the underlying pavement structures and drainage systems, installation of a 1" asphalt overlay, curb stops replacement and restriping.

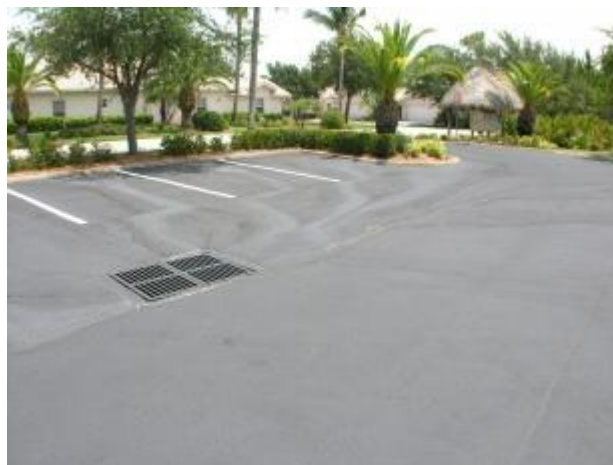
Sealcoating/rejuvenation serves as not only a cosmetic upgrade; it also insures minimal moisture intrusion into the underlying pavement structure. Without a proper moisture barrier, premature deterioration in the form of potholes, etc. can occur, causing the need for more frequent (and costly) asphalt overlays. As reported, the association completed this expense for the clubhouse parking lot in 2011, and plans on sealcoating the roadways in late 2011. This analysis assumes that sealcoating of the roadways will be completed. The market reflects a typical useful life of 3-4 years for this upgrade. The current costs include typical minor pavement repairs and restriping.

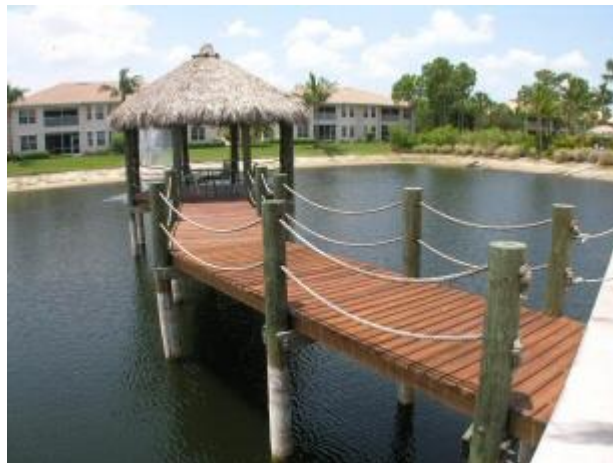
Assuming proper and routine maintenance, including as needed board replacements, sealing/waterproofing, and barring any unforeseen storm damages, a life cycle in the low to mid 10 year range is the market norm we have observed for major restoration of wood decking like that at the subject's boardwalk. The current cost estimate includes replacement of the wood decking and typical minor repairs to the underlying framing, stringers, and pilings. This cost is not reflective of total replacement, which should not be necessary in the foreseeable future under normal conditions.

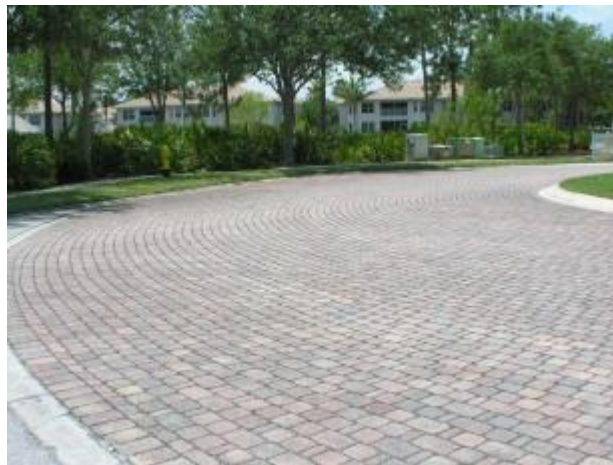
Some associations consider brick paver parking/drives, walkways, pool and spa decks, etc. to be effectively permanent, and chose to exclude replacement from their annual reserve budgets. Others do establish and fund reserves for eventual replacement, on observed life cycle estimates of +/- 20 to 40 years. It is our opinion that reserving for eventual replacement is prudent, if only for cosmetic purposes; we have observed older brick pavers that appear worn and dated, even with periodic pressure washing and/or sealing. Data gleaned from similar properties indicates a typical cost in the low \$4.00 to mid \$5.00/sq.ft.unit cost range.

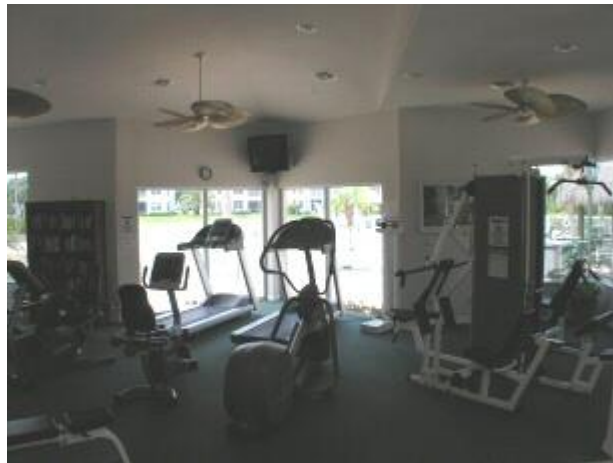
The fitness room includes average to good quality exercise equipment (2 treadmills-2009, 2 bikes-2009, 2 elliptical machines-2000/2004, and 1 multi-strength training machine-2000). Depending on the amount of usage, life cycles for cardiovascular equipment generally range from 6-10 years. A 10-12 year useful life is indicated for inventories of strength equipment. Considering the various placed in service dates and the association's operating history, for the association's consideration, we have scheduled 50% of the total estimated replacement cost to be incurred on a 5 year life cycle. The current total cost estimate of \$24,200 (50%=\$12,100) is based on the observed quality of the existing equipment and the reserve analyst's experience with exercise equipment on a lump sum and \$/piece basis. Considering the most recent expense in 2009 for the two exercise bikes, we have scheduled the next expense in 2014.

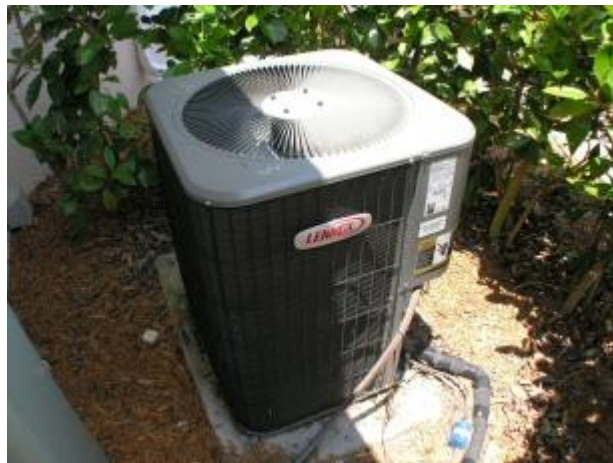
The clubhouse is supported by a single 4 ton HVAC split unit. The market suggests a useful life in the 20 year range for interior air handlers, while exterior ground mounted condenser units should be expected on a 12-14 life cycle, which is typical of the market. As reported by other associations, the state of Florida requires replacement concurrently for corresponding air handlers and condenser units. The current cost estimate is based on the size in tons and our experience with this type of equipment on an average \$/ton basis.

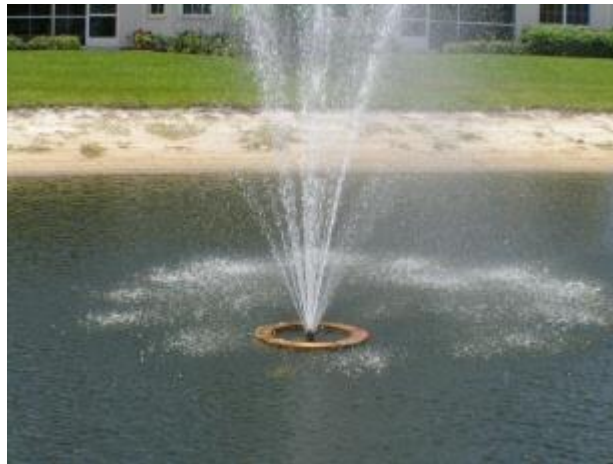
The retention lakes are supported by three lake fountains. Some associations choose to fund as needed repairs/upgrades on an as needed basis through their operating budgets, while others choose to maintain reserves for this type of equipment. We have observed typical life cycles of 12-15 years for replacement of lake fountains; this life cycle recognizes that over the life of these systems, pump rebuilds/replacements and other minor upgrades will be necessary as a function of general maintenance. A separate line item was included for each fountain, since their replacement may not be necessary concurrently.

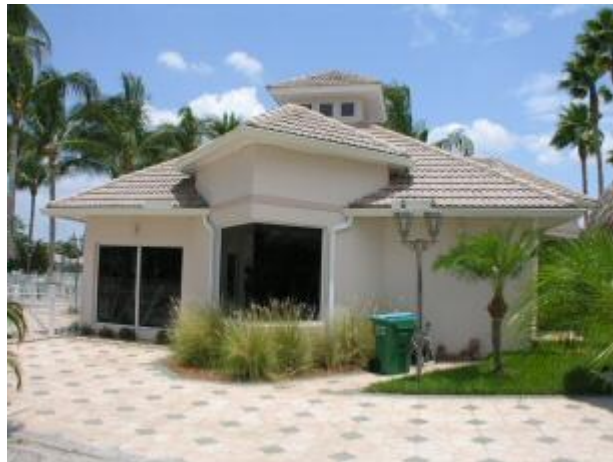
To insure proper protection of the underlying concrete, stucco, metal, and wood surfaces, the market reflects a maximum 6 to 7 year life cycle for exterior painting and waterproofing. The current cost is an order of magnitude cost estimate based on the observed size of the clubhouse and guardhouse. This cost includes typical minor exterior repairs, surface preparation, as needed window and door caulking/waterproofing, repainting of all exterior surfaces including the window frames.

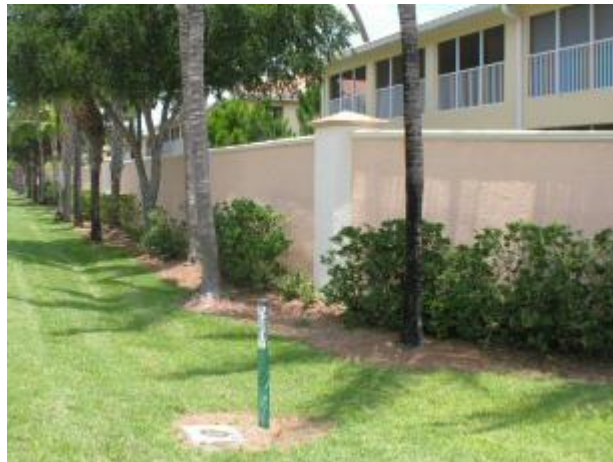
A line item was included for painting the concrete/foam perimeter wall across the front of the property. The +/- 6ft tall (2 sides) wall was measured to be approximately 1,620 linear feet. The total square footage of surface area equates to +/- 19,440 square feet. As reported, this expense was last incurred in 2011. We have scheduled a typical market supported 7 year useful life thereafter. This expense includes as needed structural/stucco repairs, surface preparation, and paint.

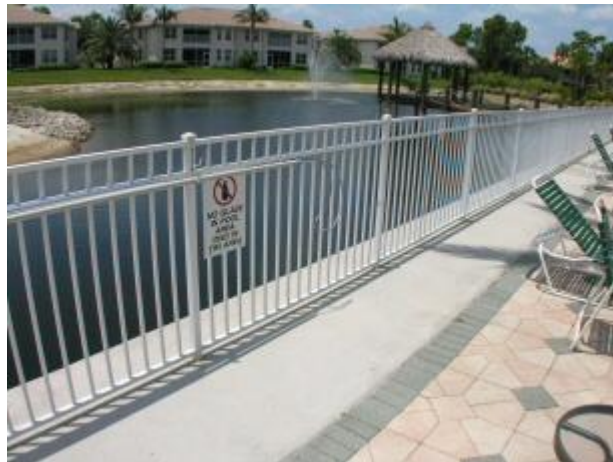
Assuming routine maintenance, total replacement of the metal fencing and gates at the pool perimeter should be expected on a life cycle in the low to mid 20 year range. The current cost estimate includes removal and disposal of the existing fencing and gates and replacement with fencing and gates of similar height and quality, and is reflective of the total approximate linear feet and a market supported cost per linear foot.

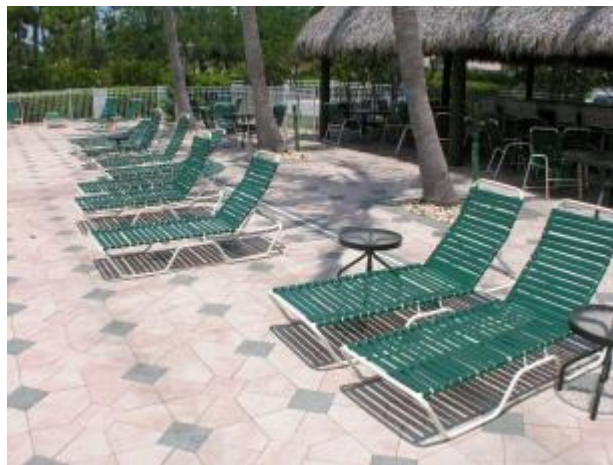
While minor replacements/additions should be expected from time to time, properties like the subject generally complete major pool and spa deck furniture inventory replacements on a 10-12 year life cycle. As reported, major restrapping and additions were completed in 2009/2010. As such, the association should not expect total replacement anytime in the near future. The current cost estimate is based on the quality of the existing inventory (30 lounge, 40 chairs, 13 tables, and 13 bar stools), retail pricing guides, and our experience with pool furniture replacement on both an average \$/piece and lump sum basis in similar quality pools. Actual costs may vary depending on the type and quality of furniture chosen in the future.

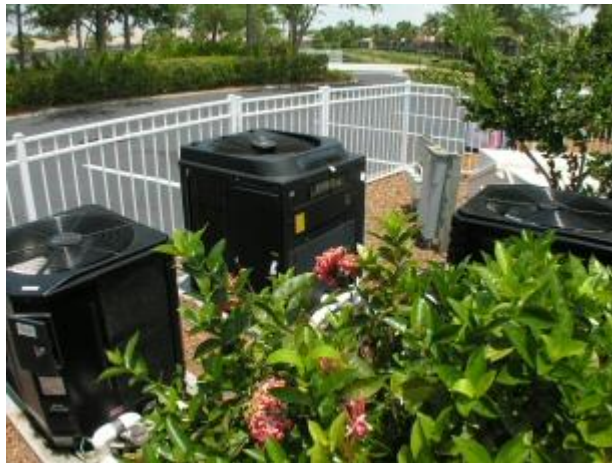
Under normal operating conditions, total replacement of the inventory of pool and spa equipment (pumps, filters, chlorination systems, heaters, etc.) should not be necessary at any one given time. Some associations do establish and fund reserves for as needed equipment replacements, while others prefer to fund as needed expenses through their annual operating budgets as a function of general maintenance. For the association's consideration we have provided an allowance of \$15,000 on a future 10 year life cycle to provide monies for as needed replacements of the pool and spa equipment. Since no plans were reported to complete major expenses relating the to pool and spa equipment in 2012, we have adjusted the next expense date in 2013 for as needed equipment replacements.

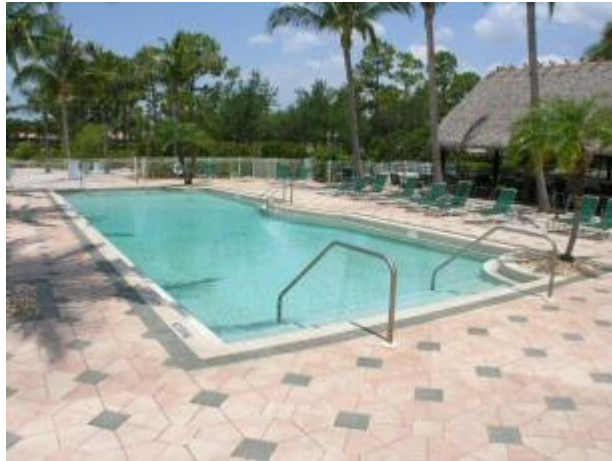
With proper installation, chemical balancing, and routine maintenance, pool interior resurfacing/restoration can be expected on a 10-12 year life cycle. Due to the higher temperatures and chemical concentrations, resurfacing of concrete/gunite spas is generally necessary on an 8-10 year life cycle under normal conditions. Assuming resurfacing has not been completed since the installation date, we have adjusted the next expense to be completed in 2012. A recurring 10 year life cycle was scheduled thereafter. The current cost estimate is based on the total square feet of the pool interior, at a market supported \$12.10 for the +/- 1,200 square feet of surface area, plus an allowance of \$2,600 for resurfacing the spa interior. The current cost includes typical minor structural/tank repairs, tile upgrades/replacements, and installation of new aggregate surface materials (“diamond brite”, “pebble crete”, etc.)

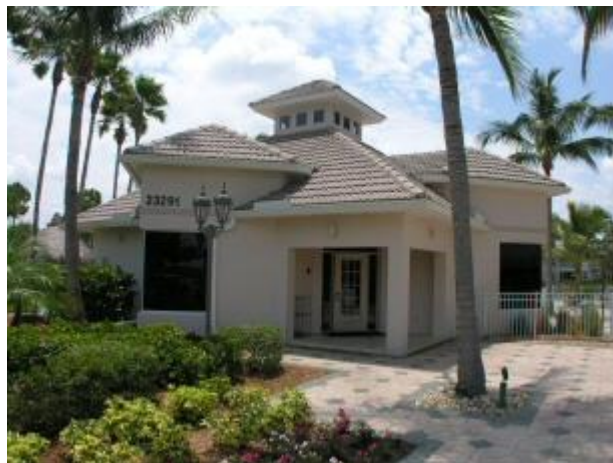
Roof Replacement, Clubhouse

Assuming proper installation and routine maintenance, tile roofing, like that at the clubhouse (+/- 17.5 squares*) and guardhouse (+/- 2.1 squares), does not typically require replacement prior to a 25-30+ year life under normal operating conditions. The current replacement cost includes tear off and disposal of the existing roofing, typical minor repairs to the underlying roof structures, flashing, as needed repair/replacement of fascia, soffits, and/or gutters and downspouts, and installation of like roofing.

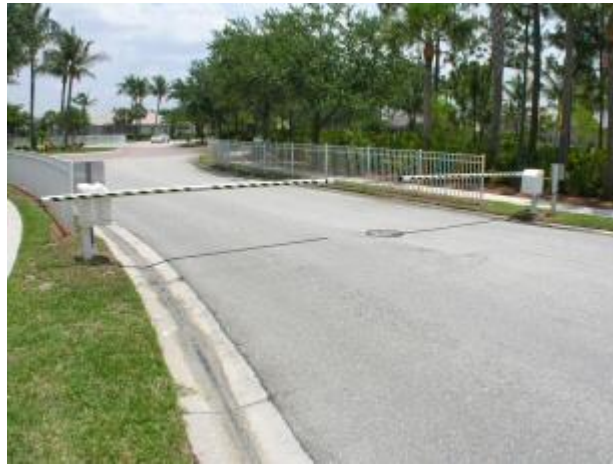
Barring any unforeseen vehicular damage, replacement of the two automatic barrier gates/operators should be necessary on a 12-14 year life cycle. We have utilized a 14 year life cycle and have scheduled this expense for 2014, based on the estimated placed in service date of 2000. Each gate/operator was assigned a current replacement cost estimate of \$3,200, which includes removal and disposal of the existing units, typical minor electrical upgrades, and installation with a similar quality.

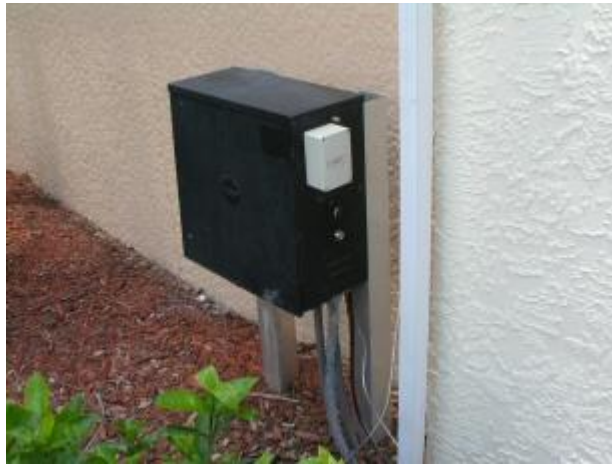
Barring any unforeseen vehicular damage, etc., replacement of the automatic security gate operators should be necessary on a life cycle of 12-15 years; some units may require replacement sooner, while others may last slightly longer. As reported, the association is currently in the process of replacing the two operators that service the four metal security gates at an actual third party cost of roughly \$2,000. Based on the operating history, we forecast that replacement of the two operators will be necessary over a 12 year life cycle, accordingly.

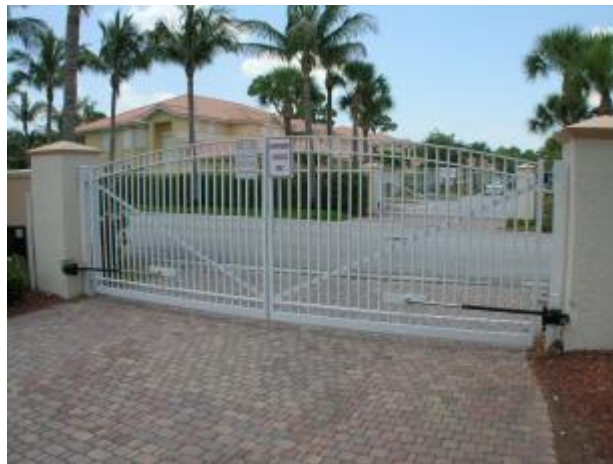
Security Gates Replacement

Barring any unforeseen vehicular damages, replacement of the four decorative metal swing gates should not be necessary for 20-25+ years. This life cycle assumes that periodic painting/refinishing is completed as a function of routine maintenance. A 25 year life cycle suggests this expense in 2025.

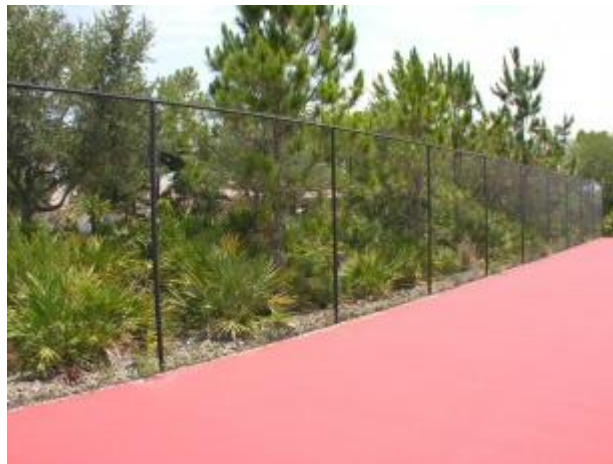
A maximum life cycle in the mid 20 year range has been observed for replacement of standard chain link tennis court fencing. The current cost estimate includes removal and disposal of the existing fencing and gates and replacement with like height/quality, and is based on our experience with tennis court fencing on both an average \$/linear foot and \$/court basis.

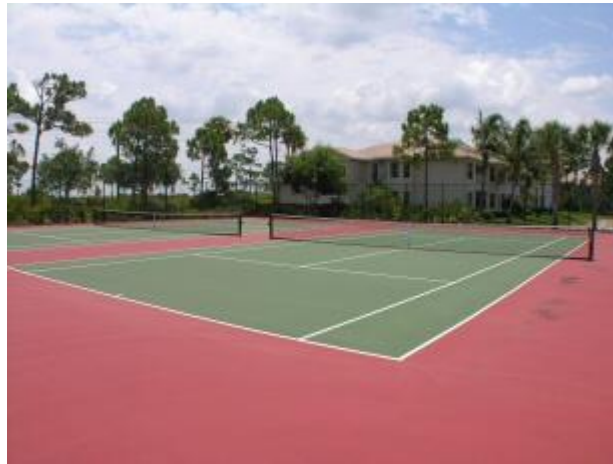
The market suggests replacement on a 6-8 year schedule, to insure proper protection of the underlying waterproofing systems and decking, as well as a high cosmetic appeal. As reported, the association has plans to complete this expense in 2011. This analysis assumes that this project will be completed. The current cost estimate includes typical minor court structural repairs.

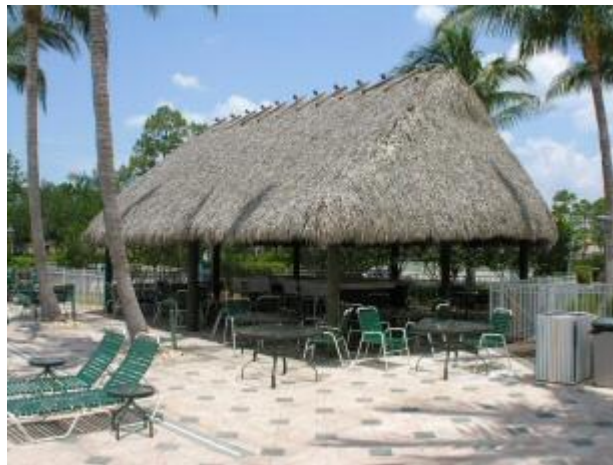
The association maintains 1 +/- 850 square feet tiki hut by the pool deck, and 6 smaller tiki hut structures. While total replacement of the wood structures should not be necessary under normal operating conditions, restoration/replacement of the straw roofs can be expected on a 6-8 year life cycle. For the purposes of this analysis, we have provided an allowance of \$6,000 for the larger structure, and \$1,500 for each of the smaller tiki huts. Assuming some measure of restoration/replacement occurred within the past few years, we have scheduled the next expense accordingly.
